Monitoring the Shoreline Dynamics of Manamoc Island, Cuyo, Palawan

Abstract

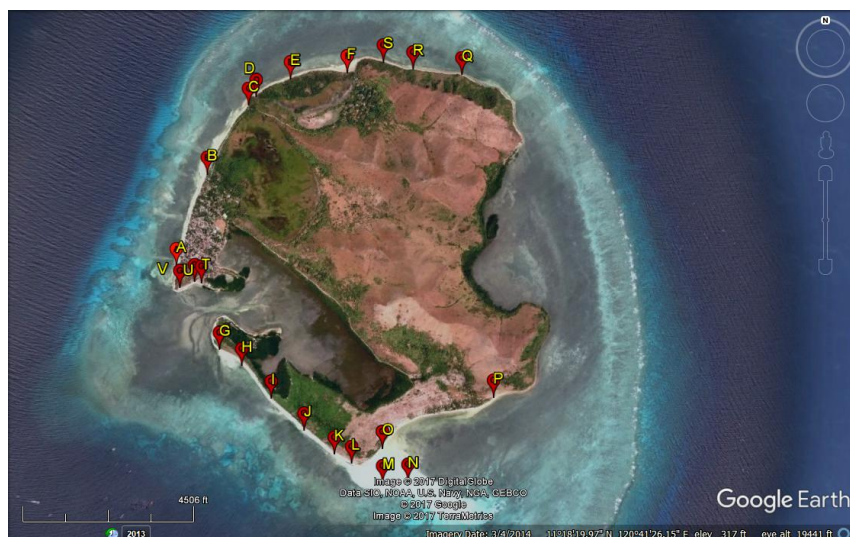
Fig 3. Map of Manamoc Island showing the location points sampled for beach profiling (Base map from Google Earth).

Beach profiling was done following the principle of the stadia method or differential survey or leveling described in the book of La Putt (1987). Figure 3 shows the sampling points. The following instruments were used: a GPS, stadia rod, Abney-hand-level, and Stanley Fatmax portable laser level instrument. Beach profiling was done during low tides. Time, coordinates, initial elevation per sampling point, height, and distances were recorded. Succeeding elevations were computed and plotted in a graph using Microsoft Excel.

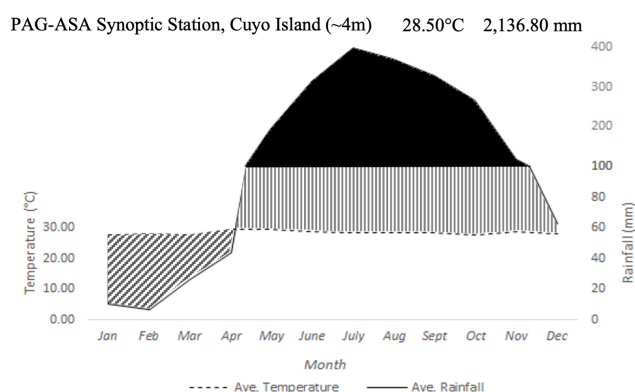
Fig 4. Climogram for Manamoc Island using average monthly temperature and rainfall of 29 years (1985–2015) (Source of Data: PAG-ASA, Quezon City).

Analysis of 29-year rainfall data of the nearest PAG-ASA station in Manamoc Island shows Climate Type 1 which was characterized by a distinct dry period from November to April and the wet season from May to October as shown in Figure 4. Annual precipitation was 2,136.8mm and the average temperature was 28.5°C. Since typhoons rarely visited this part of the country, most of the precipitation on the island was brought by the southwest monsoon. The wettest month was July and the driest month was February. The hottest month was during April.

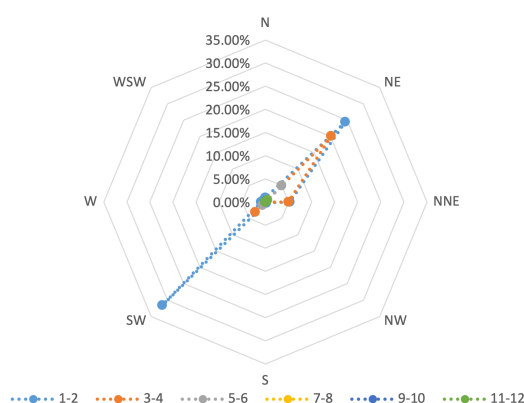
Fig 5. Windrose diagram showing the direction and velocity (in mps) of wind dominant in Manamoc Island using the average wind data of 29 years. Three prevailing winds: NE – northeast, SW – southwest, and NNE – north-northeast. The diagram was generated using Microsoft Excel. (Source of data: PAG-ASA, Quezon City)

The 29-year wind data revealed that three dominant wind systems prevailed on the island: northeast, southwest, and north-northeast wind (Figure 5). Northeast was the most prevalent among the three (50.15%). Other directions of winds recorded were north-northeast (NNE) and west (W). Generally, the wind velocity ranges from 1mps to 12mps.

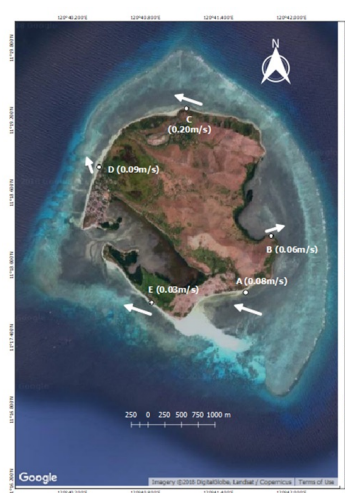
Fig 6. The velocity of longshore current at different points of Manamoc Island. Shown inside the red circle was the uneven seabed of the northwest beach indicating the difference in water depth. The map was generated using QGIS. Base map from Google Earth.

One of the physical processes affecting the dynamics of the Manamoc shoreline was longshore drift. During sampling, the prevailing wind was from the northeast and the tide level was 1.07–0.24m. Results revealed that the longest average drift was in *Calampisao* with 0.20ms^{-1} going in the N-NW direction and the shortest was in *Luyo* with 0.03ms^{-1} in the same direction (Table 1 and Figure 6). This was due to the location of each site. Since *Calampisao* (C) was exposed to (northeast monsoon) NEM, longshore currents were also strong in this section and moving in the same direction as NEM. The implication of this was that the longshore current strengthened by NEM caused the sands in this section to be transported in the direction of NEM. Whereas *Luyo* was relatively hidden from the influence of NEM hence longshore current was weak in this section. Therefore, the retention time of sands was longer resulting in sand deposition in this area. Points B and D did not follow the direction of the prevailing wind which is unusual. This was due to refraction, the bending of sea waves because of the change in the water depth. As waves approach the shallow water in the nearshore area, both the speed and magnitude of the waves decrease resulting in to change in direction or bending.

Other natural processes affecting the beach are tides. This was best explained by the unusual observation in the longshore drift experiment in Site B (Table 1 and Figure 6) wherein the orange moved opposite to the wind-driven current. Aside from wave refraction, the retreating tide also influenced the longshore current at point B. The upper sea surface appeared to be moving along with NEM, the sea current moved opposite. Also, since the sampling area was at the near end of the embayment, the longshore current trailed the contour of the island. So generally, on high tides, more sands were subjected to longshore drift, the opposite is true during low tides.

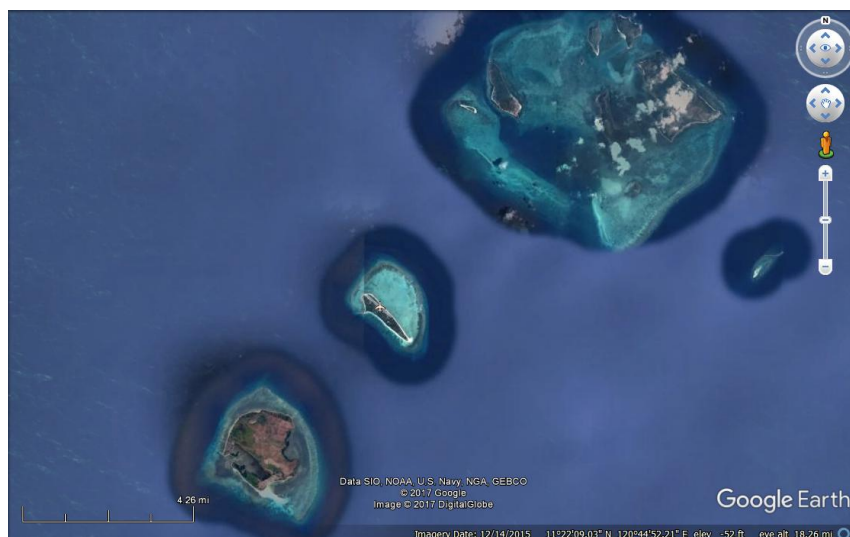
Fig 11. The Quiniluban Group of Islands in the northeast of Palawan. Composed of Manamoc Island (lower left), Pamalican Island (center), Tinutuan Island, Tayay Island, Algeciras Island, Mandit Island, and Quiniluban Island (upper right). Image source: Google Earth.

Parallel to Manamoc Island is the neighboring island of Pamalican (Figure 11) which was also reported to be retreating. In the Environmental Performance Report and Management Plan (EPRMP) prepared by Seastems, Inc. (2007) for Amanpulo Resort in Pamalican Island, Barangay Manamoc, Cuyo, Palawan, the island experienced a retreating coastline as early as 1990. However, it was observed that the southern tip was accreting. It has been estimated that about 280m has been added to the length of the island due to accretion from 1990 to 2007. It was suspected that the sand deposited at the southern tip was from the other sides of the island specifically from areas exposed to the NEM. These were the same observations as in Manamoc Island.
